**ELECTRICAL SAFETY FOLLOW UP INSPECTION REPORT (3<sup>RD</sup>)**

<b>Factory Name</b>	<b>Intimate Attire Ltd (Mahdeen Group)</b>					<b>Note:</b>
<b>Address</b>	HOLDING NO 5/19 JAMIRDIA VALUKA MMENSINGH 2240					
<b>FACTORY ID</b>	<b>22994</b>	<b>ELECTRICAL SAFETY INSPECTION DATES</b>				<b>Other Factory:</b>
<b>Initial Inspection Date</b>	07-Jun-2014	Date of 5 <sup>th</sup> Follow Up		Date of 11 <sup>th</sup> Follow Up		
<b>Report Received Date</b>		Date of 6 <sup>th</sup> Follow Up		Date of 12 <sup>th</sup> Follow Up		
Date of 1 <sup>st</sup> Follow Up	04-Jun-2018	Date of 7 <sup>th</sup> Follow Up		Date of 13 <sup>th</sup> Follow Up		
Date of 2 <sup>nd</sup> Follow Up	14-Mar-2019	Date of 8 <sup>th</sup> Follow Up		Date of 14 <sup>th</sup> Follow Up		
Date of 3 <sup>rd</sup> Follow Up	26-Sep-2019	Date of 9 <sup>th</sup> Follow Up		Date of 15 <sup>th</sup> Follow Up		
Date of 4 <sup>th</sup> Follow Up		Date of 10 <sup>th</sup> Follow Up		Date of 16 <sup>th</sup> Follow Up

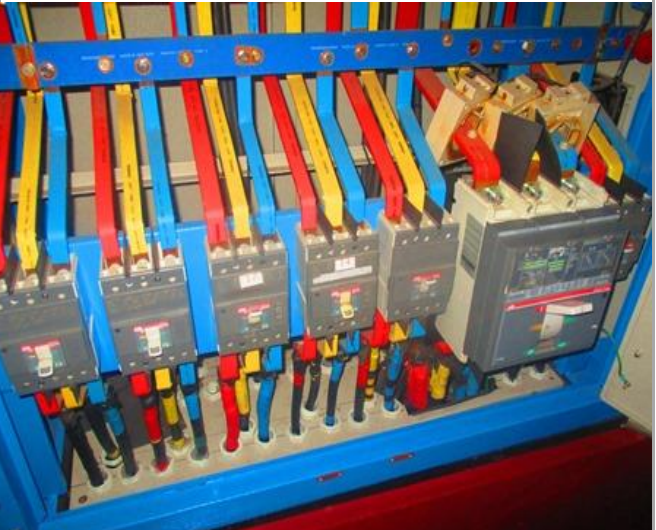
Item No	Accord Inspection Observation	Accord Action Plan (Recommendation)	Accord Time line (given in report)	Comments from Accord (After Physical Inspection)	Final Timeline (Approved timeline)	Final Action Plan (Factory)	Progress Status (On the date of inspection)	Pictorial Evidence
26	All Distribution boards lack clear permanent identification markings.	As per BNBC section 2.11.5.4 ensure clear and permanent identification marks are painted in all distribution boards, switchboards, sub main boards and switches.	Jun 7 2014	On 04/06/2018: Corrected	25-Apr-2015		Corrected	
27	Distribution boards lack capacity information labels.	Provide capacity information labels (Maximum current rating, no of circuit breakers etc.) for distribution boards.	20/07/2014	On 04/06/2018: Corrected	18-Feb-2016		Corrected	
28	Electrical cables are not properly identified. Though color code is maintained, no individual tagging or numbering on cables.	Ensure the means of identification is obtained by separate color coding, marking tape, tagging, or other approved means.	Mar 8 2014	On 04/06/2018: All circuit shall have proper identification as per circuit directory. Circuit identification shall be made in a such a way that it can specify circuit location, and can make adequate discrimination from other circuit. Means of identification may be done by providing separate color coding, marking tape, tagging, or other approved means. On 14/03/2019: Not Corrected. <b>On 26/09/2019: Not corrected.</b>	31-Mar-2016		In Progress

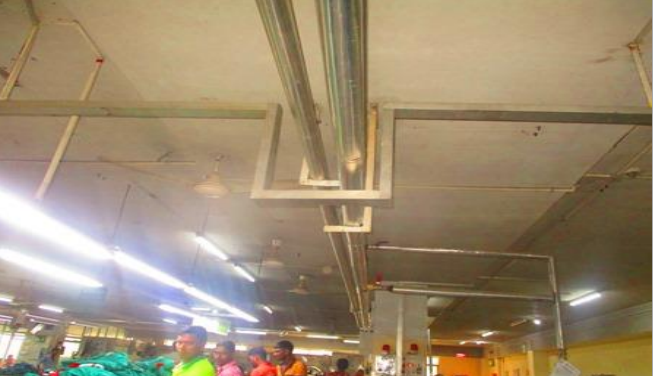
Item No	Accord Inspection Observation	Accord Action Plan (Recommendation)	Accord Time line (given in report)	Comments from Accord (After Physical Inspection)	Final Timeline (Approved timeline)	Final Action Plan (Factory)	Progress Status (On the date of inspection)	Pictorial Evidence
53	New Finding: Heat source (or exposed steam line) is adjacent to electrical installations (cable channel/duct).	Heat source (or steam line) must be kept at least 0.9 meter apart from any electrical installation. In unavoidable case, heat source shall be covered by proper and adequate insulator.	1 Month	<b>On 26/09/2019:</b> Corrected.	21-Apr-2019		Corrected

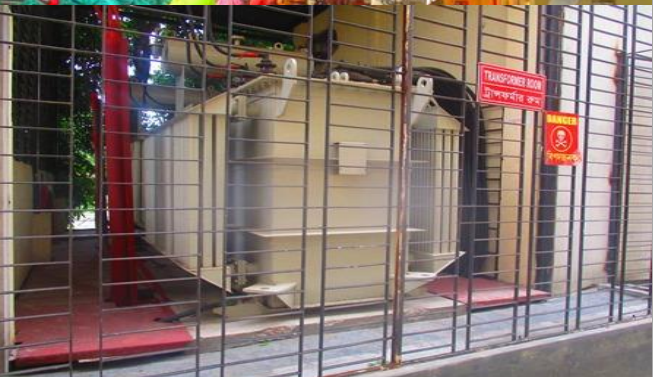
54	New Finding: Inadequate working space around transformer for performing maintenance work.	Minimum working space (1.07m) around the transformer (and related electrical installations) must be maintained	1 Month	<b>On 26/09/2019:</b> Not corrected.	21-Apr-2019		In Progress

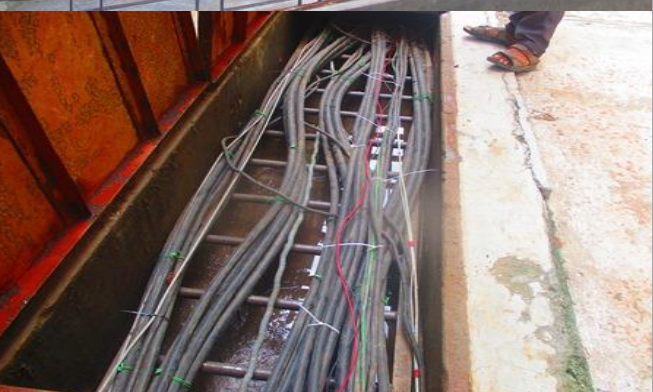
55	New Finding: Cables inside cable trench are disorganized.	Cables inside each trench shall be well organized to avoid misleading during any troubleshooting.	1 Month	<b>On 26/09/2019:</b> Corrected.	21-Apr-2019		Corrected
